TrackCircuitAssistor(TCA[®])

from Unipart Rail

Improves Track Shunting when rails are contaminated with rust

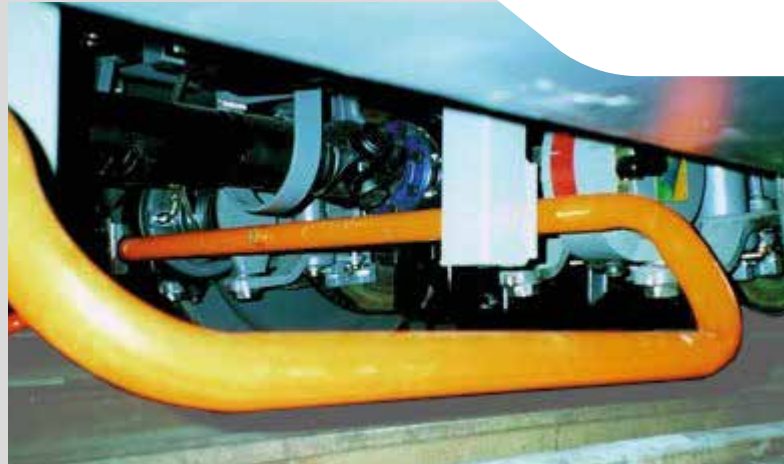
TCA[®] Principle

GMRT2477 states: "A TCA[®] is fitted between a pair of wheelsets on a vehicle. It assists the operation of a track circuit by raising the effective track circuit rail-to-rail voltage at the wheelsets either side of the TCA[®]; this enables a low voltage track circuit to operate as effectively as a higher voltage type."
